These are photos I took when I was repainting and repairing the Strevell House in Pontiac during the Summer of 2021.

Dale C. Maley
President – Livingston County Historical Society
August 2022

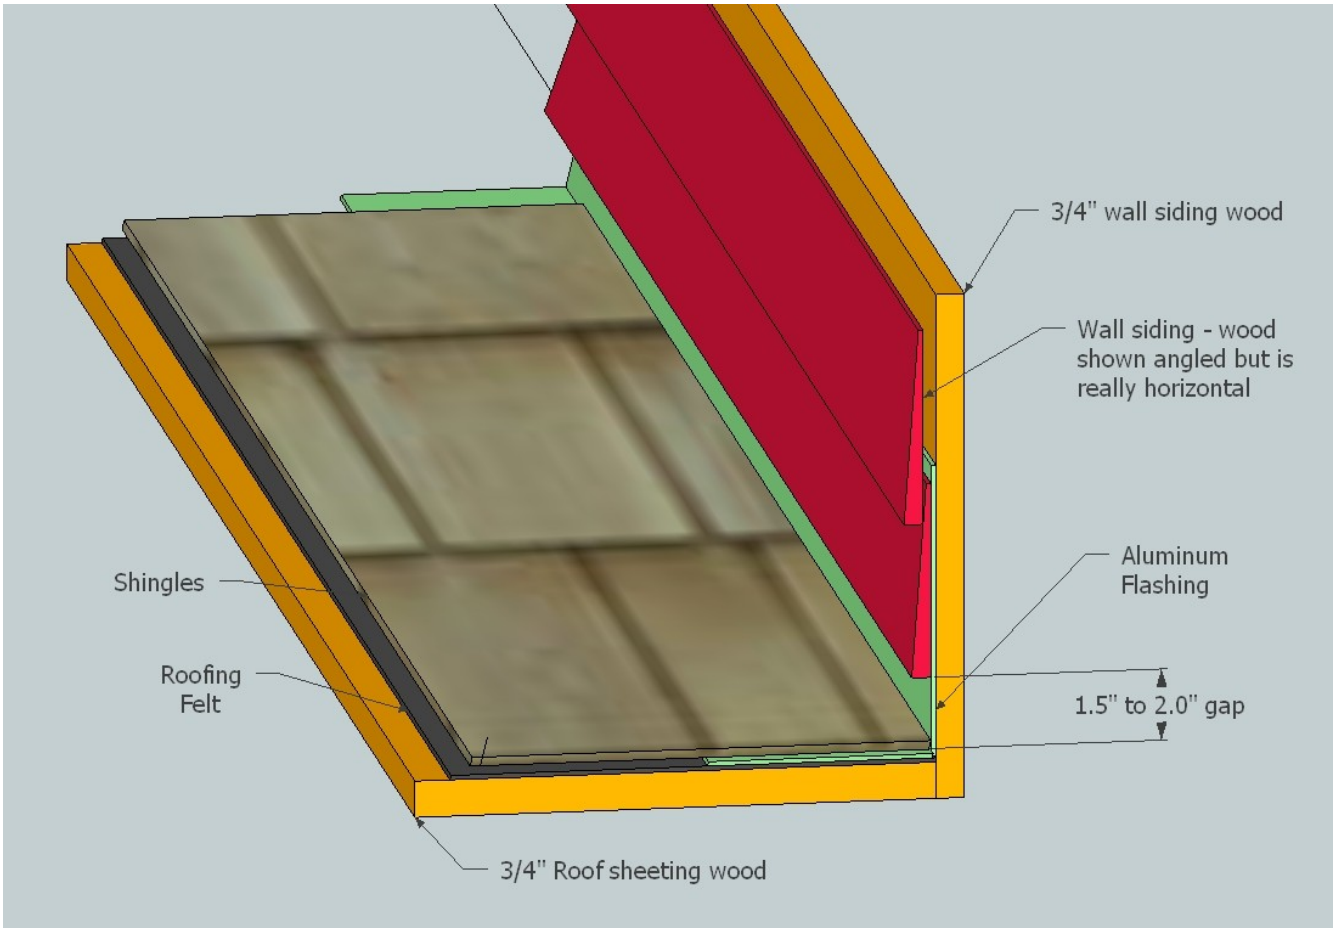
3/4" wall siding wood
Wall siding - wood shown angled but is really horizontal
Aluminum Flashing
1.5" to 2.0" gap
Shingles
Roofing Felt
3/4" Roof sheeting wood

I was very surprised that the red horizontal siding boards had started to peel badly above the west kitchen room. Water was bouncing off the shingles and soaking the lower boards each rain, causing them to decay the fastest.

I researched wood siding houses further and found that most building codes and/or inspectors require at least 2.5 inches clearance between the shingles and the mating horizontal siding, to avoid fast decay of the siding near the shingles.

By the way, internet searches said the worst fix for having the shingles touch the wood siding, was to caulk the joint……..because the caulking usually fails in a few years. This is what we have now on the Strevell house.

A contractor out east solved this problem on an older house by scribing a line about 8.5 inches above the shingles, then setting his portable circular saw to cut only deep enough to cut the siding and not the wall studs. He removed the wood siding, installed his flashing, then about 3 inches above the shingles, installed a new 1x6 or ¾ by 5.5 inch actual side trim board. Someday, the Strevell house should probably get this same treatment.

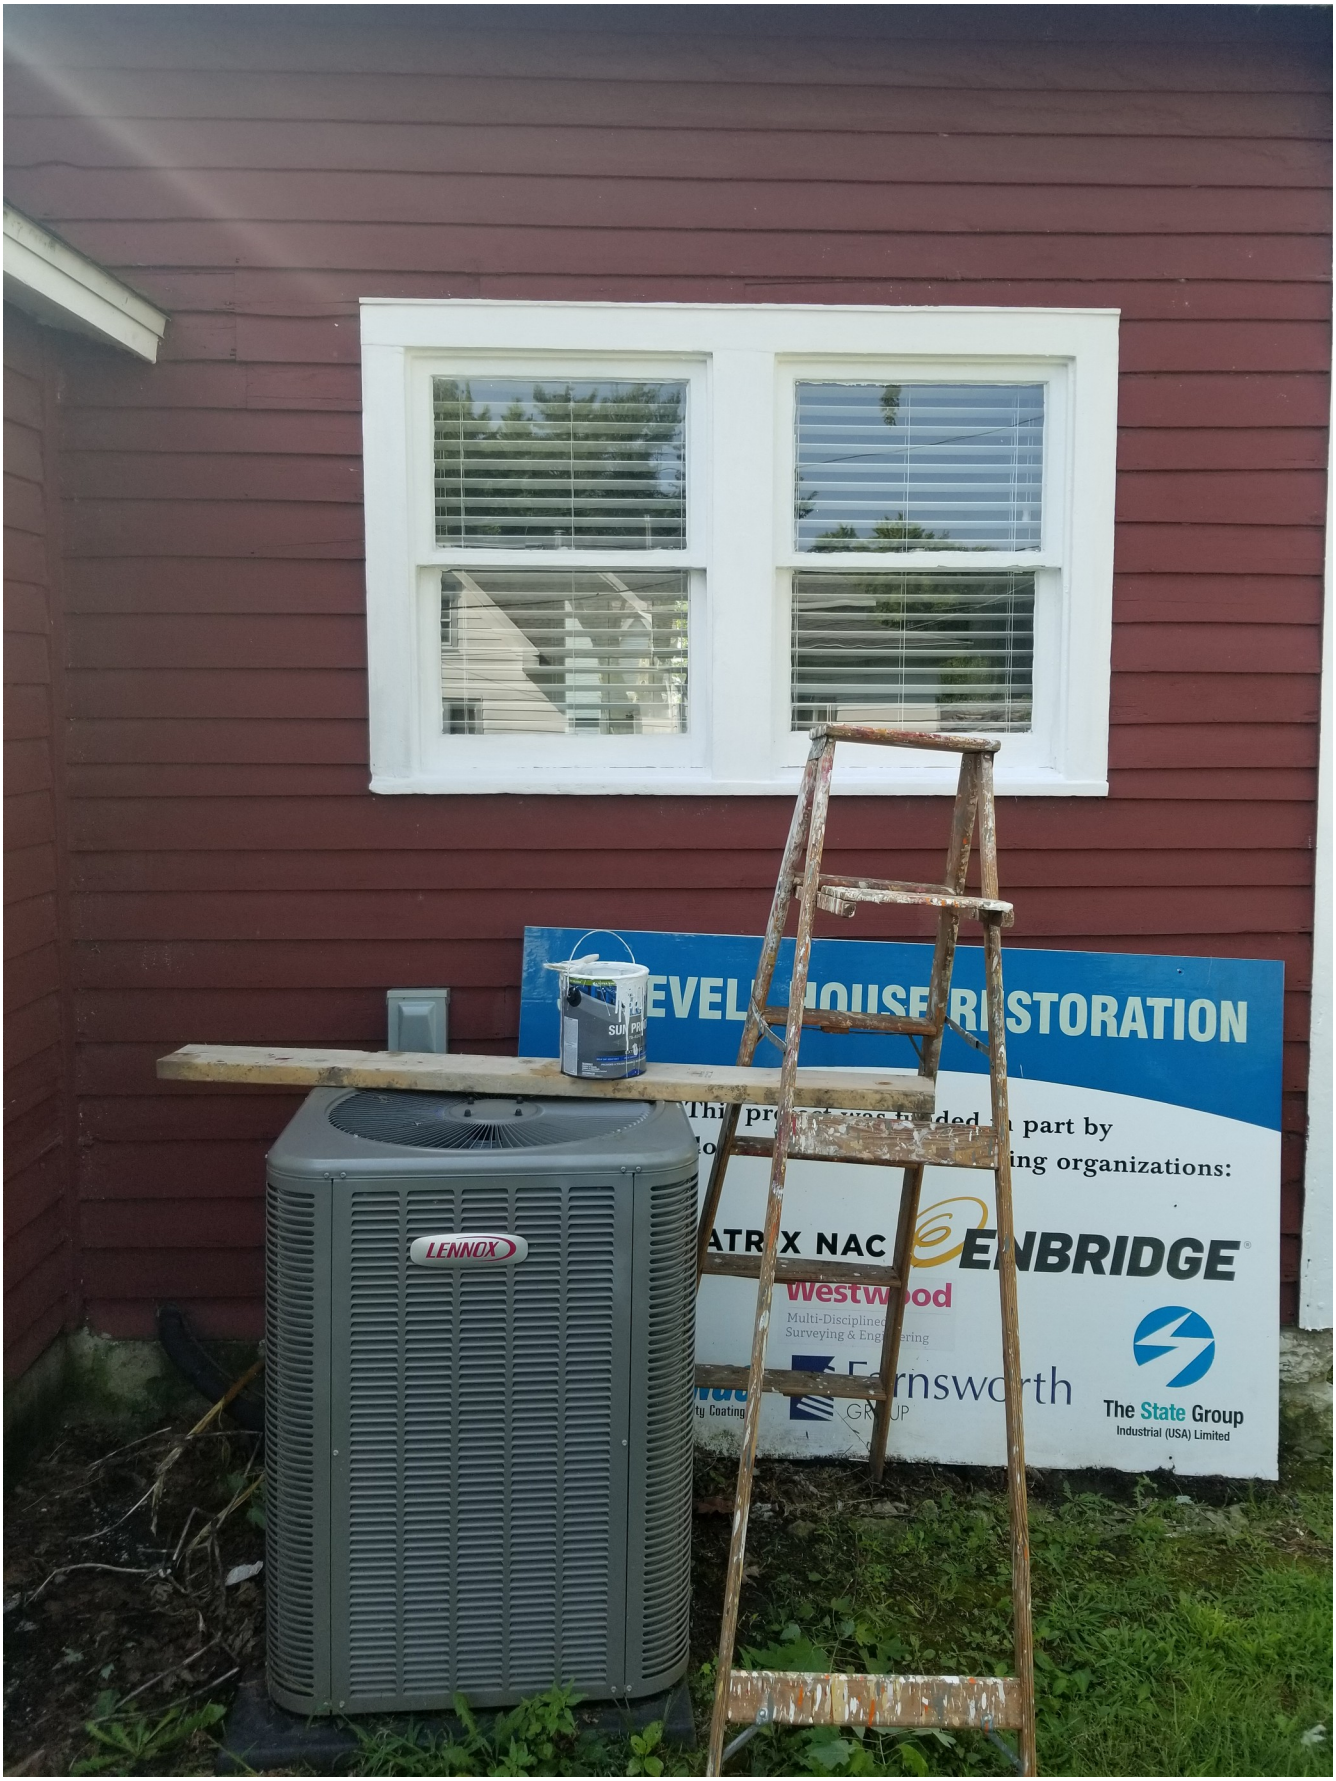
Unpainted window filler board on restroom

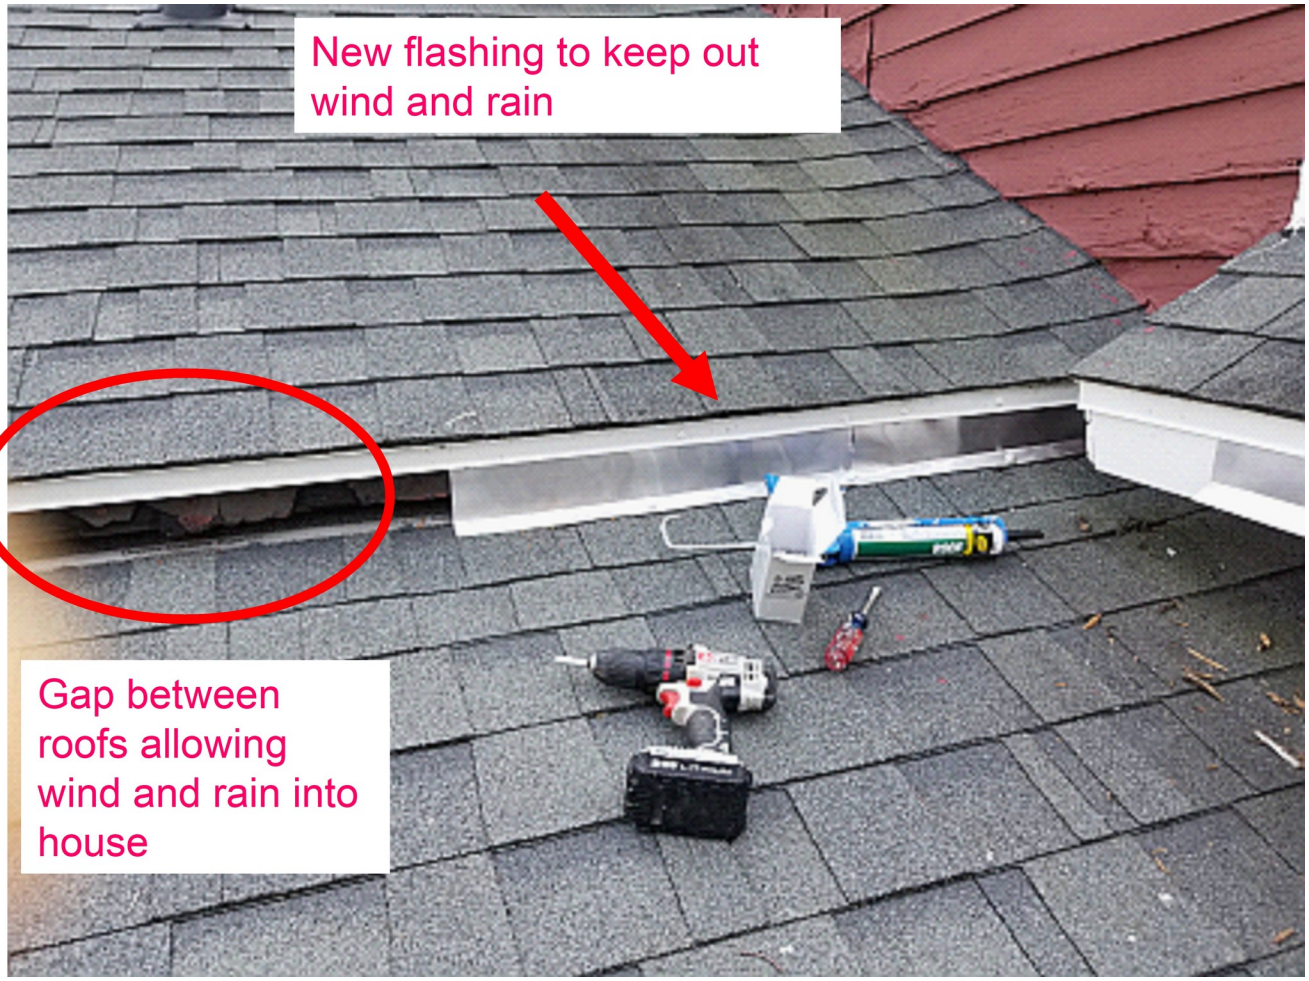
New flashing to keep out wind and rain
Gap between roofs allowing wind and rain into house

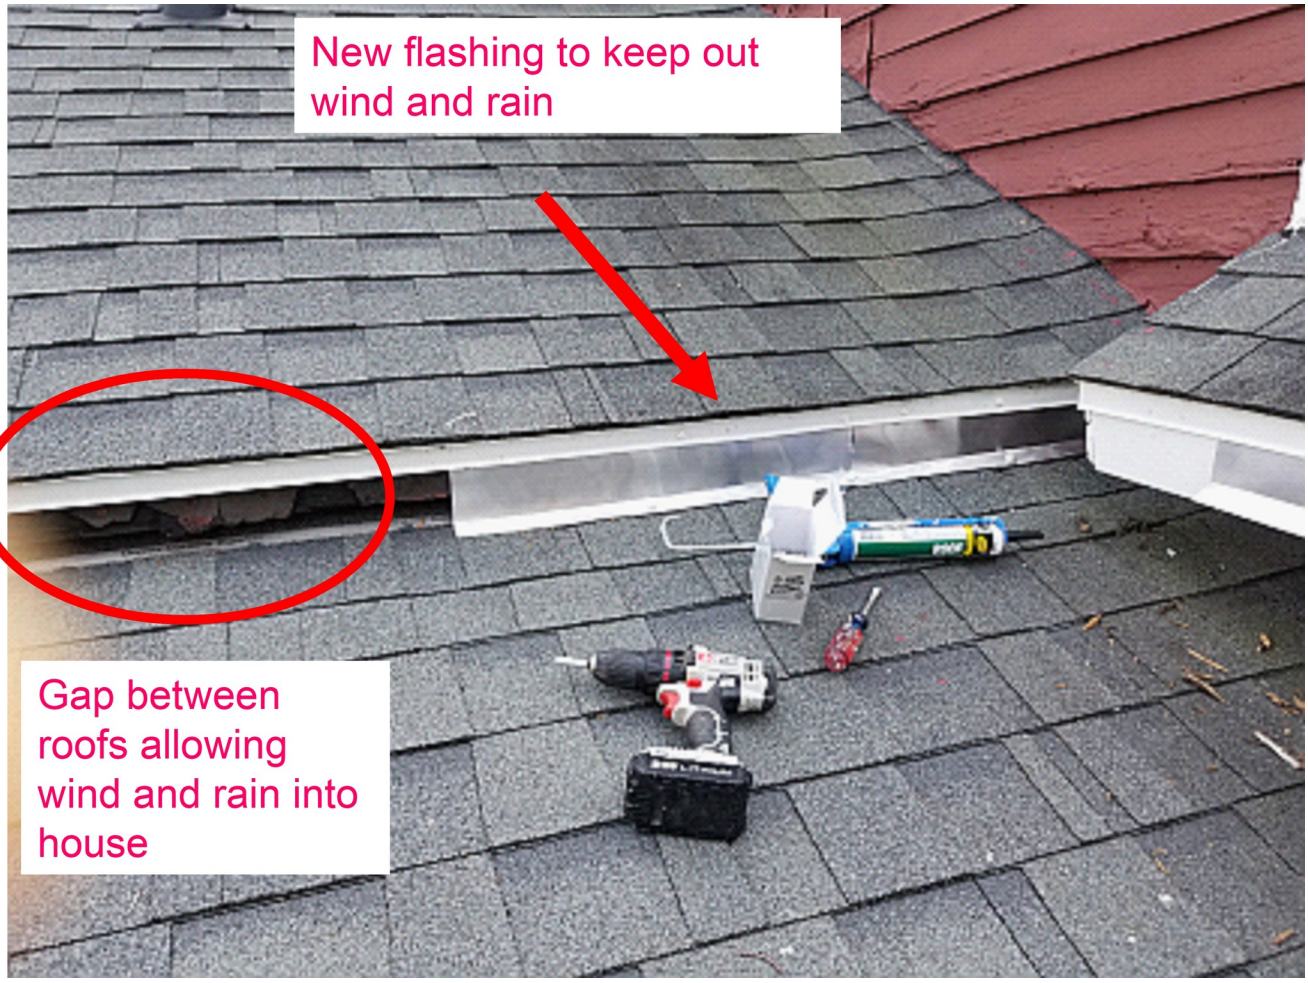
New flashing to keep out wind and rain
Gap between roofs allowing wind and rain into house
